### Final report on aircraft accident

Case no.: **25-024F003**

Location: **Suðurlandsvegur, Route 1, near Heiðmörk**

Description: **Engine failure and emergency landing on a road**

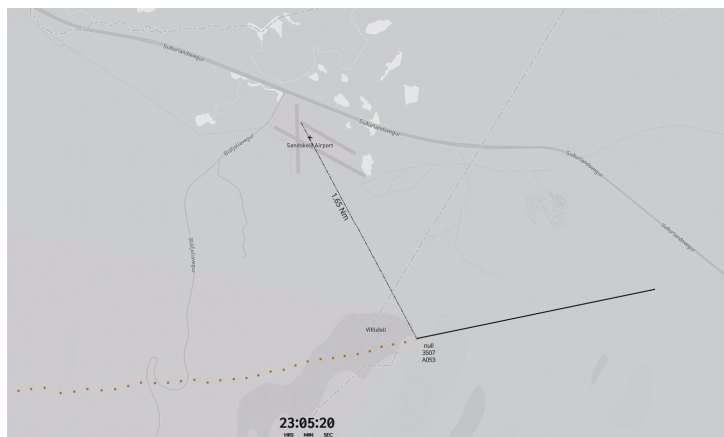
At 23:05, located about 1.6 NM southwest of RWY 13 at Sandskeið airfield (BISS), while climbing through 5300 feet altitude, the engine failed, the propeller stopped and the windshield became hard to see through, due to oil spillage. The pilot contacted ATC (Reykjavik Approach), advised of the engine failure and declared an emergency (MAYDAY-MAYDAY-MAYDAY). The pilot advised that he was turning northbound in VMC towards a

**Figure 1: Aircraft location when pilot contacted ATC at 23:05**

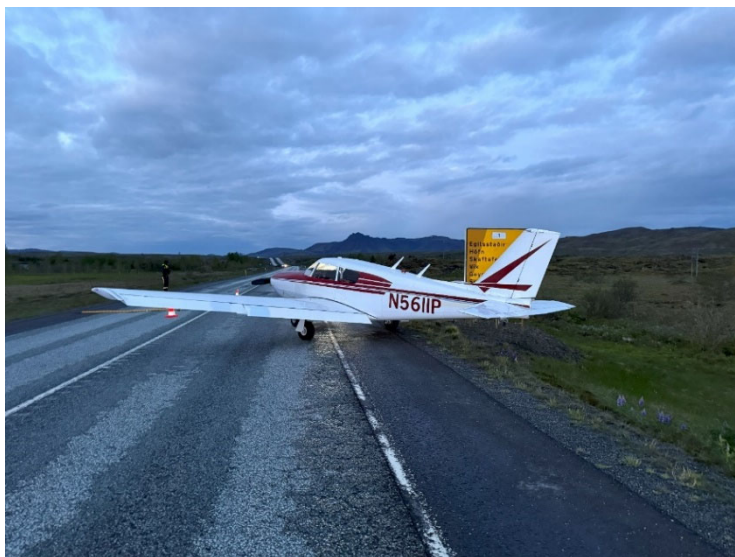
on about 2 miles apart, and landed on the road towards the east. During the landing roll the right wing hit a traffic sign and then scraped on top of a road guardrail. The aircraft came to a stop after passing the guardrail next to a large yellow road sign (Figure 2).

**Figure 2: Aircraft on Route 1 after the landing when SIA-Iceland arrived**

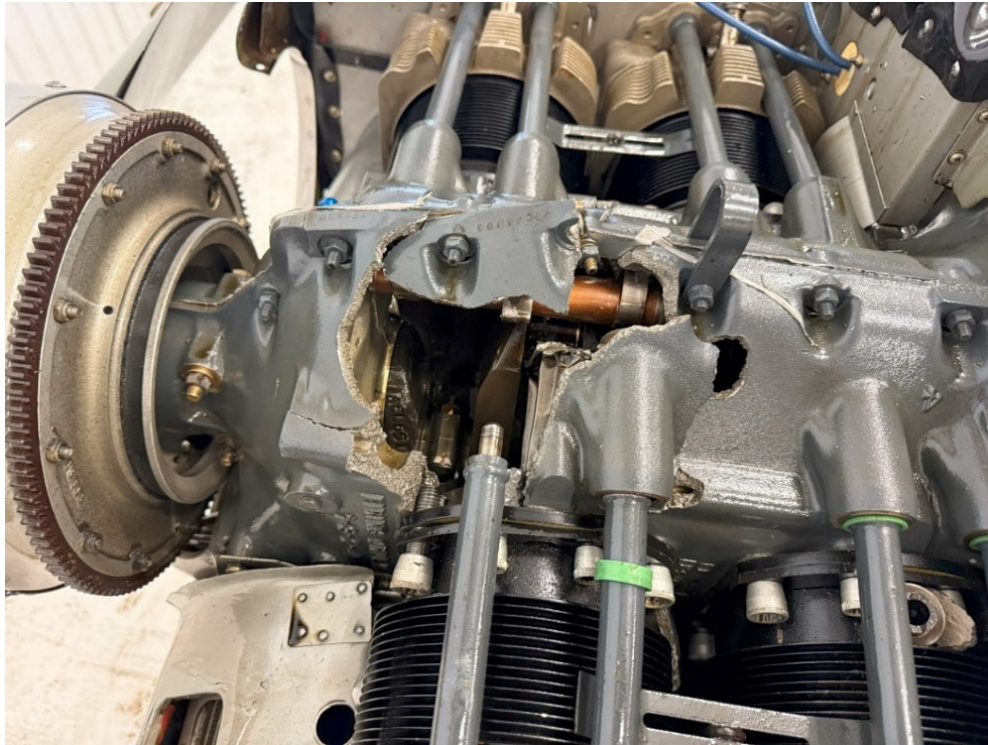
Inspection of the aircraft on site revealed that the engine had incurred a catastrophic failure (Figure 3) and the right wing was severely damaged (Figure 4).

**Figure 3: Engine damage**

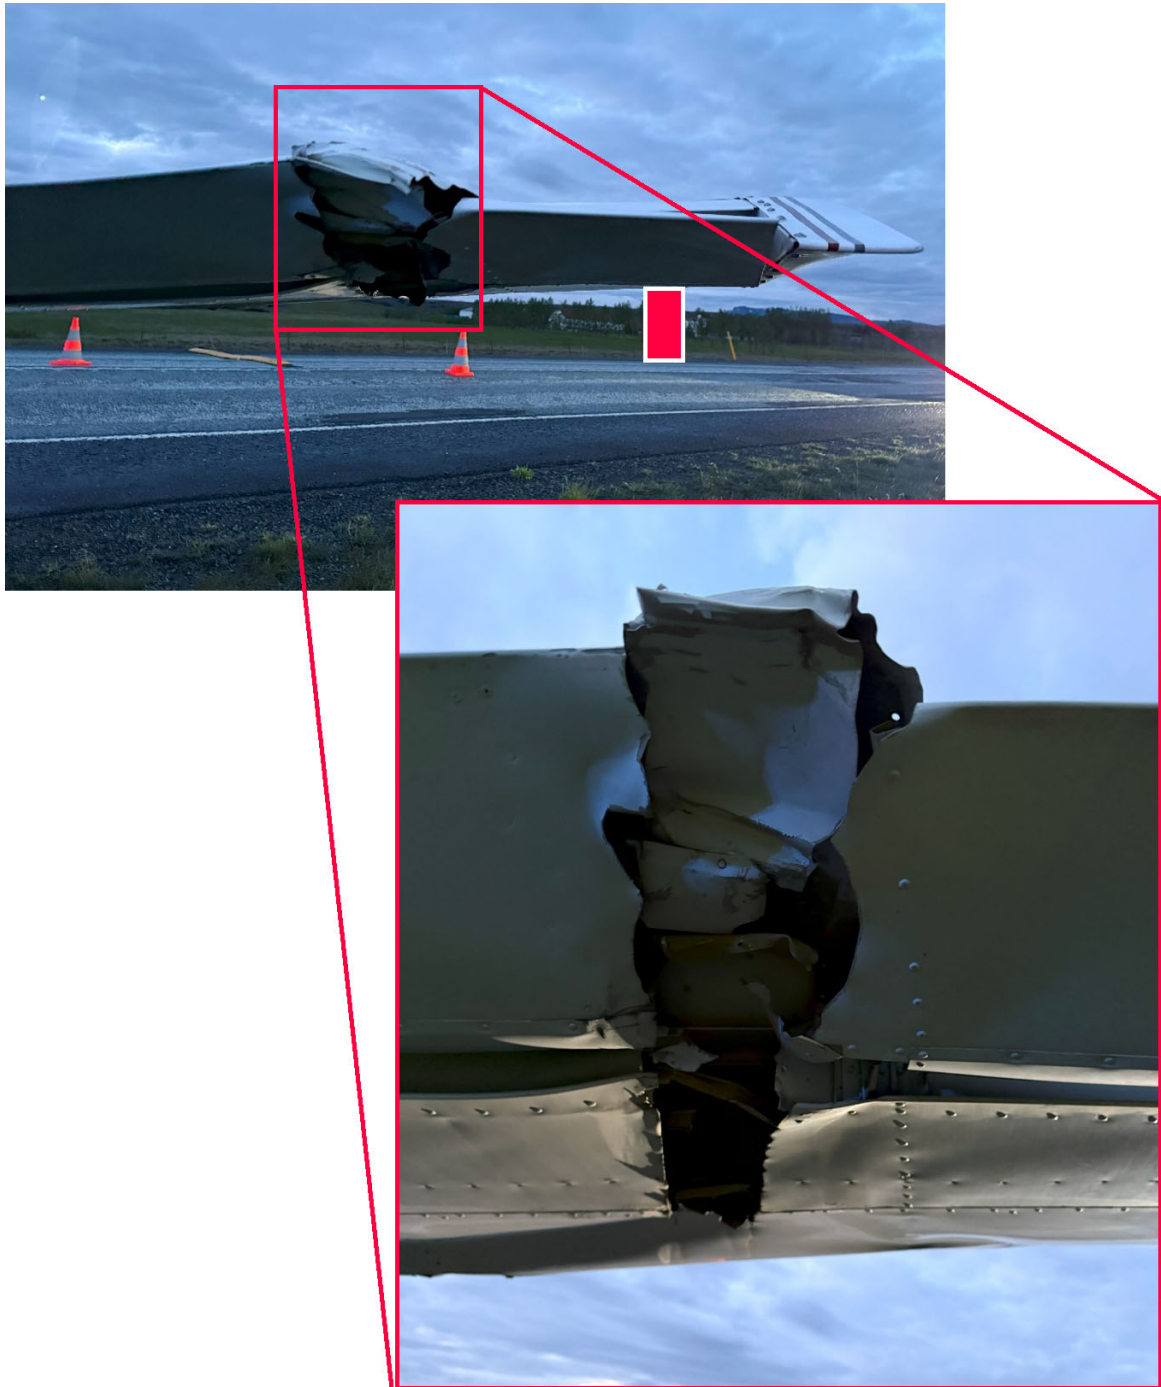
**Figure 4: Part of the right wing damage**

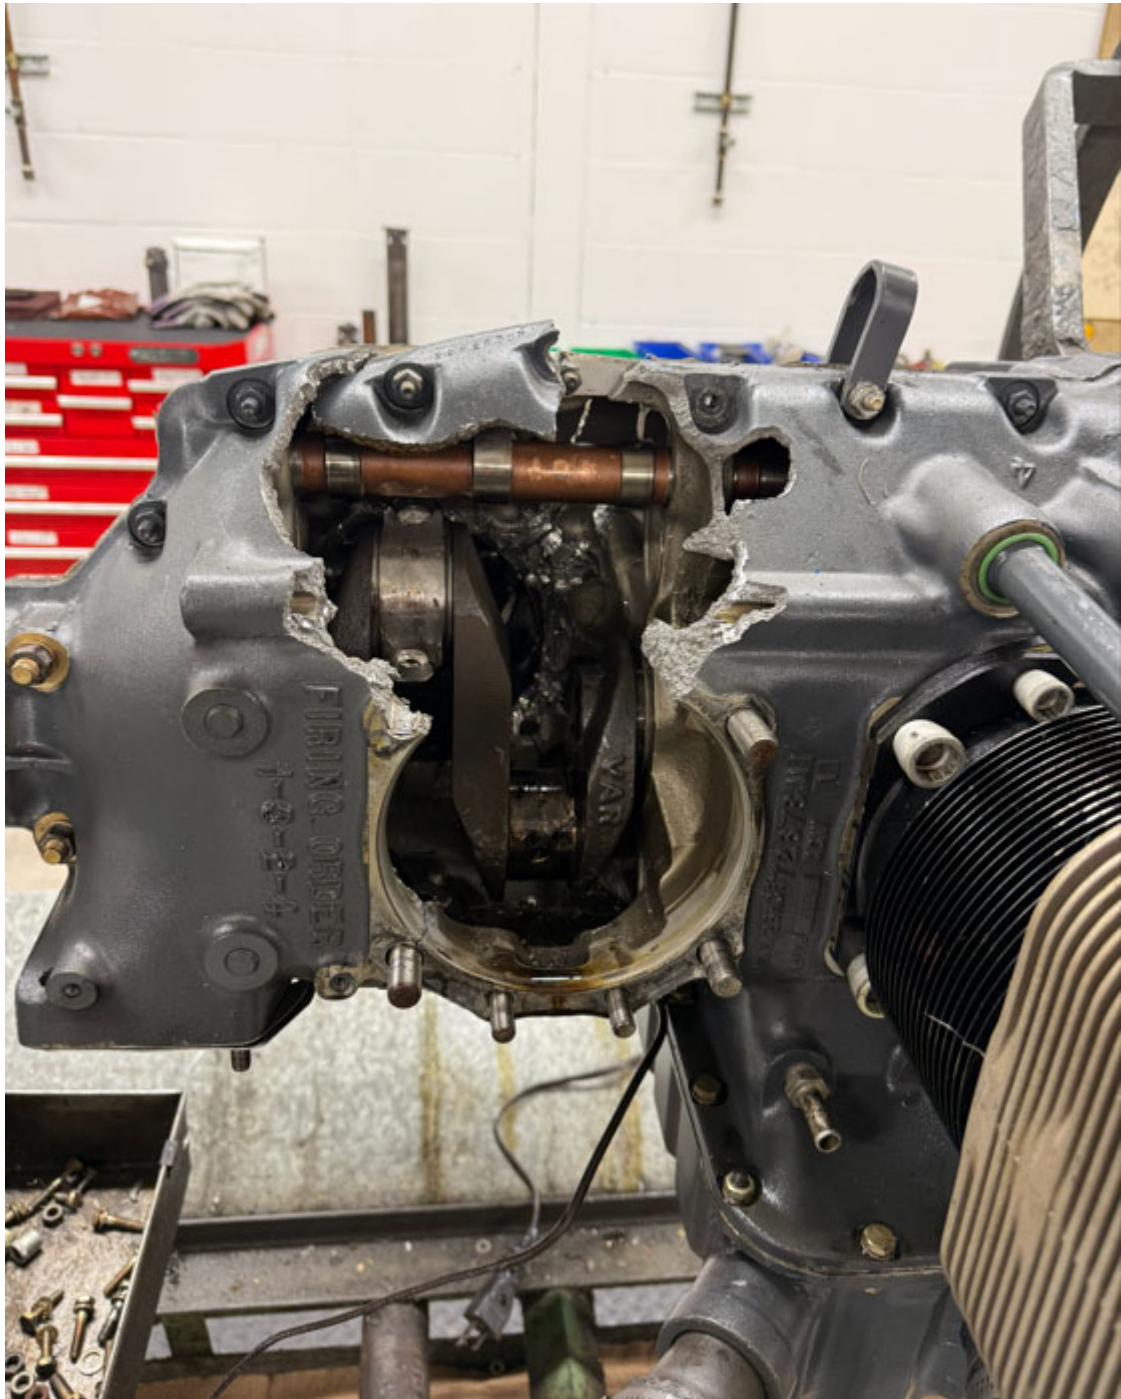
- The R/H crankcase was fractured in the center from the perimeter bolts to the cylinders #1 and #3 hold down studs
- Hand pressure was applied to the crankshaft flange, the crankshaft could not be rotated
- The #1 and #2 cylinders were removed, and hand pressure was reapplied to the crankshaft flange
- The crankshaft could then be rotated to a full 360 degrees multiple times
- Thumb compression and suction and normal valve train movement were observed on cylinders #3 and #4
- Cylinders #3 and #4 were subsequently removed from the engine

**Figure 8: Crankcase had incurred a catastrophic failure**

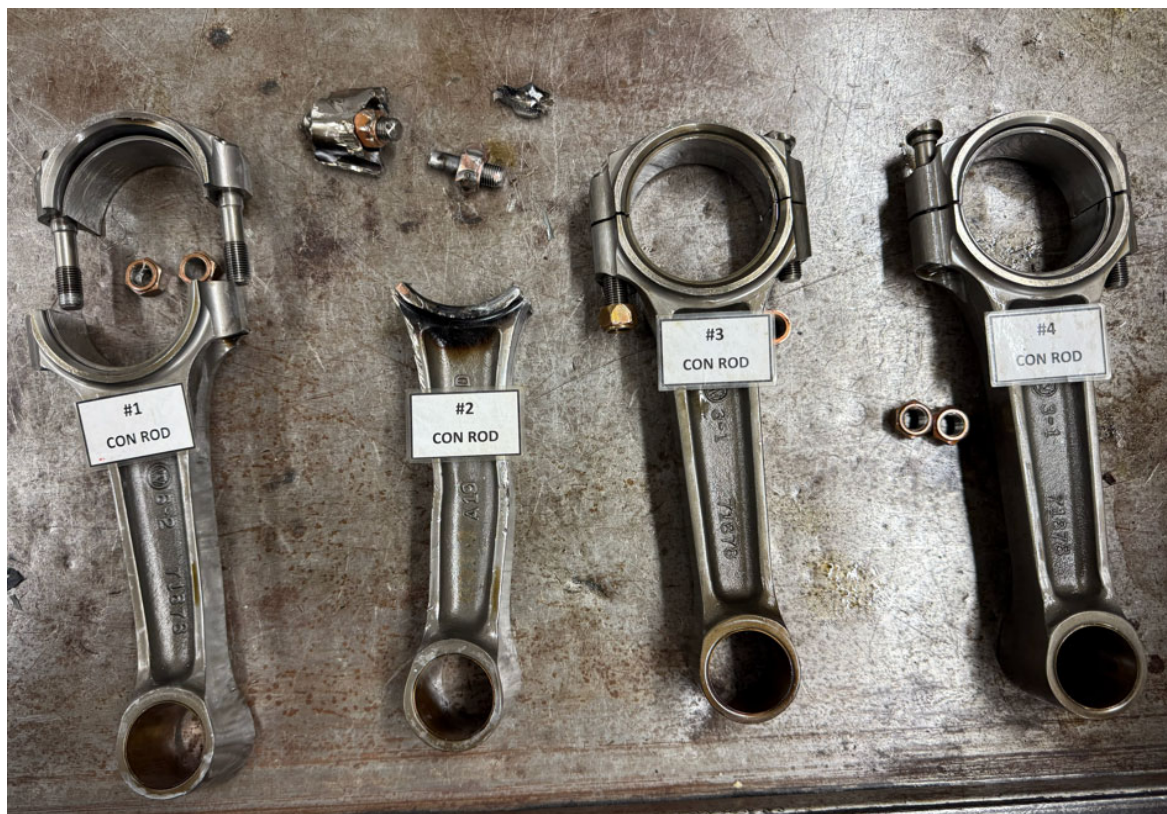
- The #1 connecting rod was bent forward along the I-beam adjacent to the small end and had gouges and abrasions across the connecting rod
- The #2 connecting rod was fractured at the big end, separating it from the crankshaft
- The #2 connecting rod cap was fragmented and the two connecting rod bolts were fractured in half

Figure 9: Connecting rods

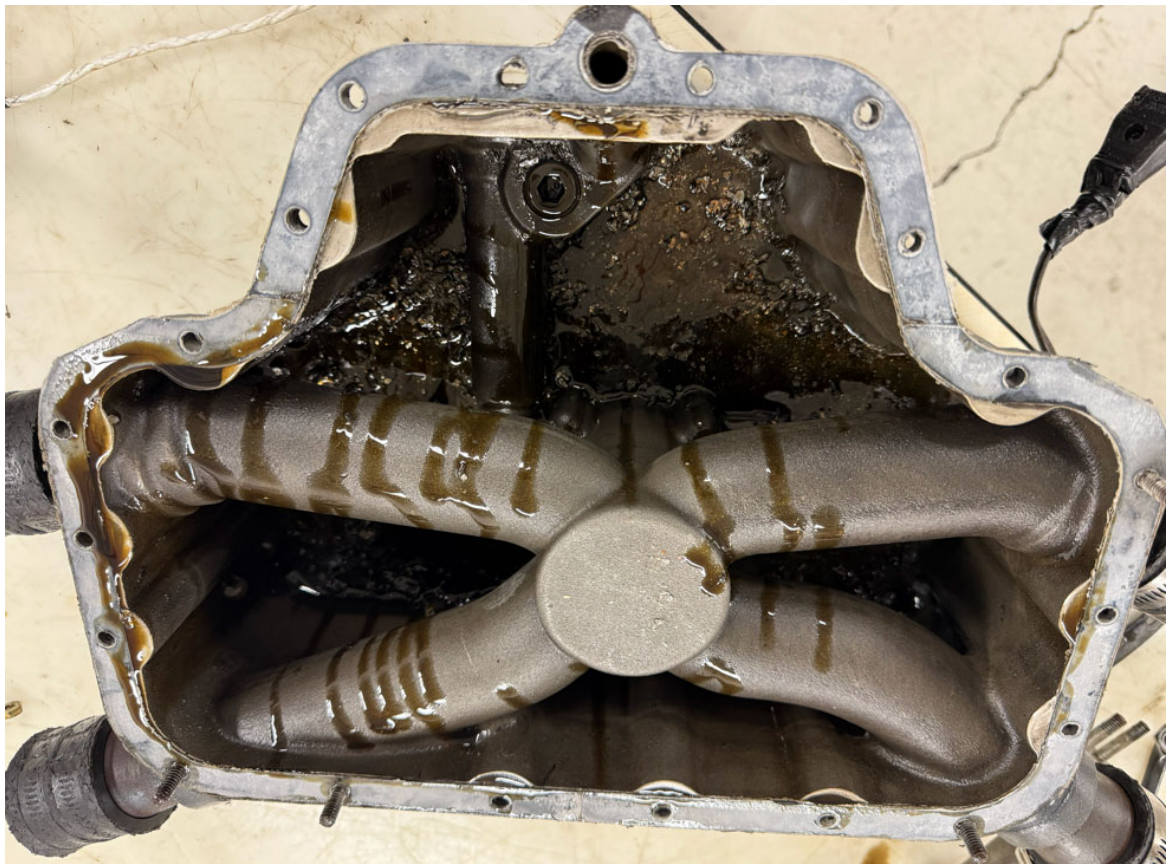
- The accessory housing and the oil sump were removed from the engine
- Oil was present in the sump; a significant amount of metal debris was observed in the oil sump
- The oil pump remained attached to the accessory housing, it was safety-wired, and the drive rotated with finger force
- The oil pump was removed; metal particles were in the oil pump body and on the oil pump impellers and circular scoring was present on the oil pump body

Figure 10: Oil sump

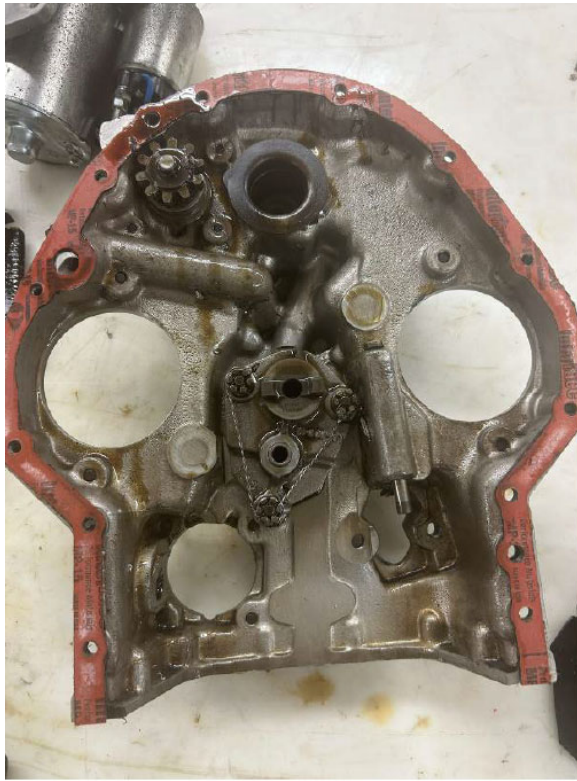
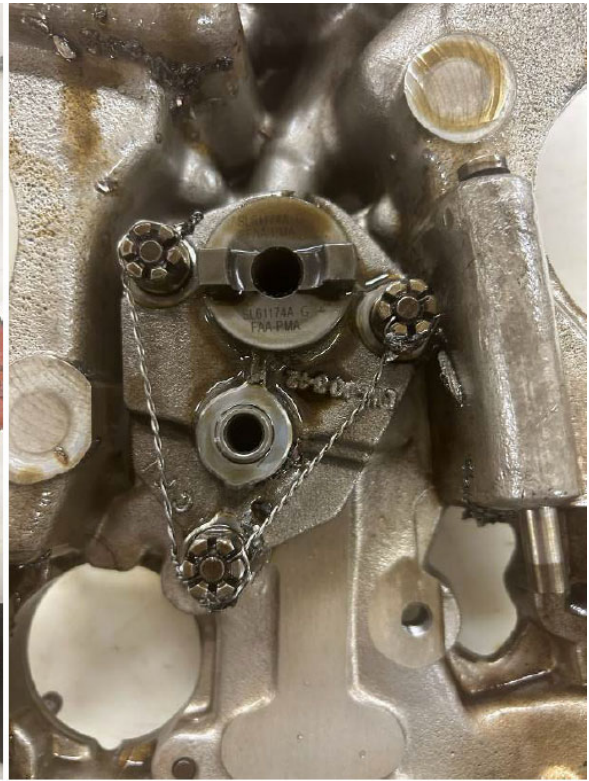
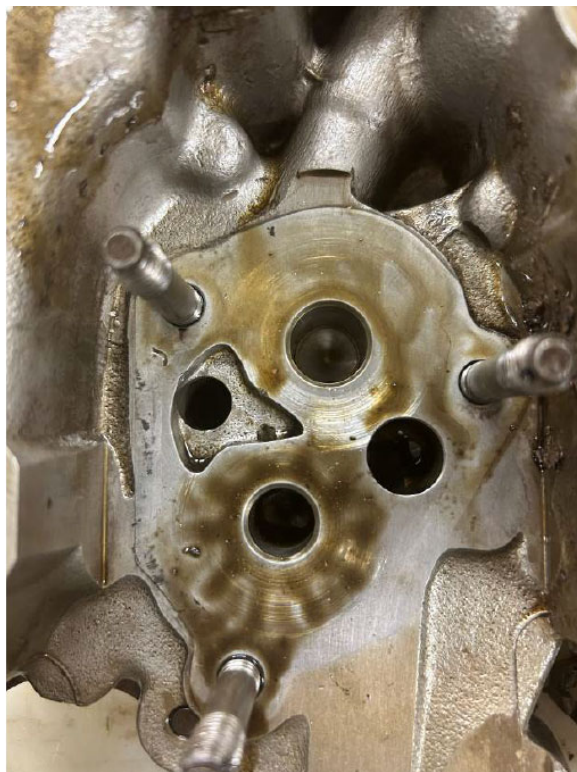
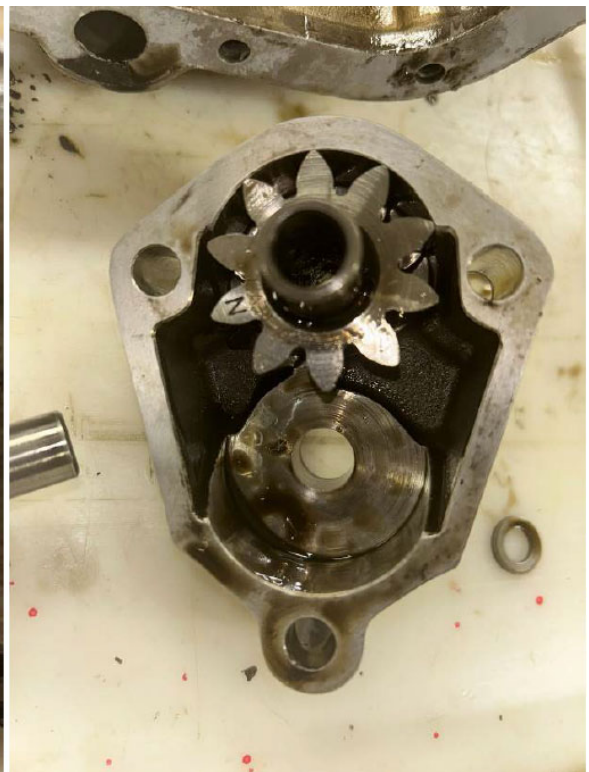
Figure 11: Accessory case and oil pump

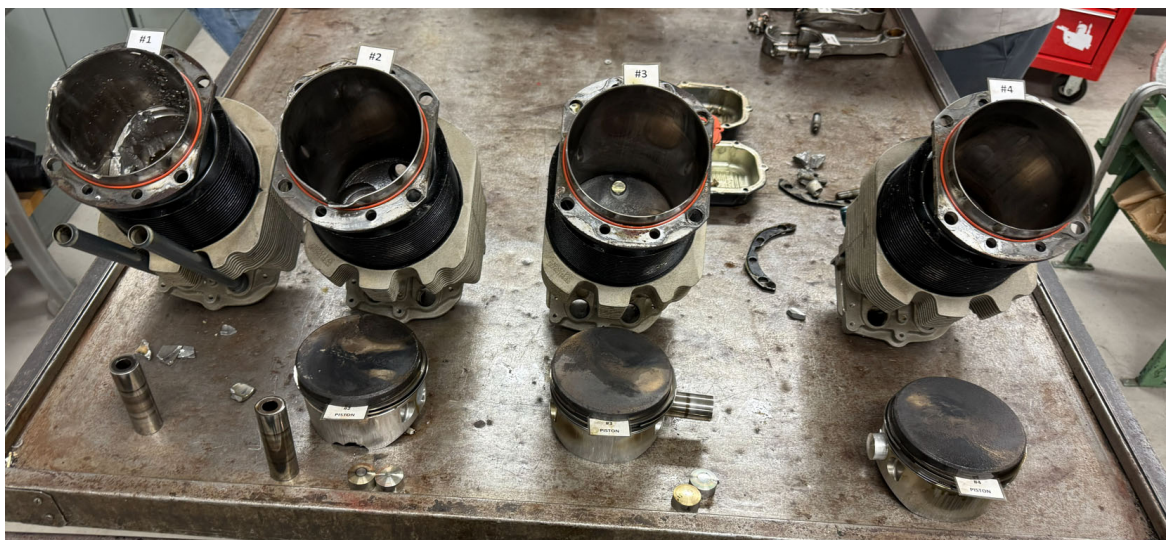
- The four cylinders were laid out on the inspection table
- The #1 piston remained lodged in the cylinder and was not removed
- The #1 piston skirt and piston pin bore were fragmented and gouged

- Pistons #2, #3, and #4 were removed, had normal combustion deposits and a visible fuel air charge swirl pattern on the face
- No broken compression or oil control rings were observed, the skirts all had vertical scoring, and the #2 piston skirt was partially fragmented

- Cylinder #1's barrel was gouged and scored, the cylinder skirt was dented and gouged
- Cylinder #2's barrel had vertical scoring in it, the cylinder skirt had gouges and dents, and on the lower center portion of the skirt, there was a dent equal in width to the width of the connecting rod I-beam

- Vertical scratches were visible on the cylinder bores of cylinders #3 and #4 but they were otherwise unremarkable

Figure 12: Cylinders

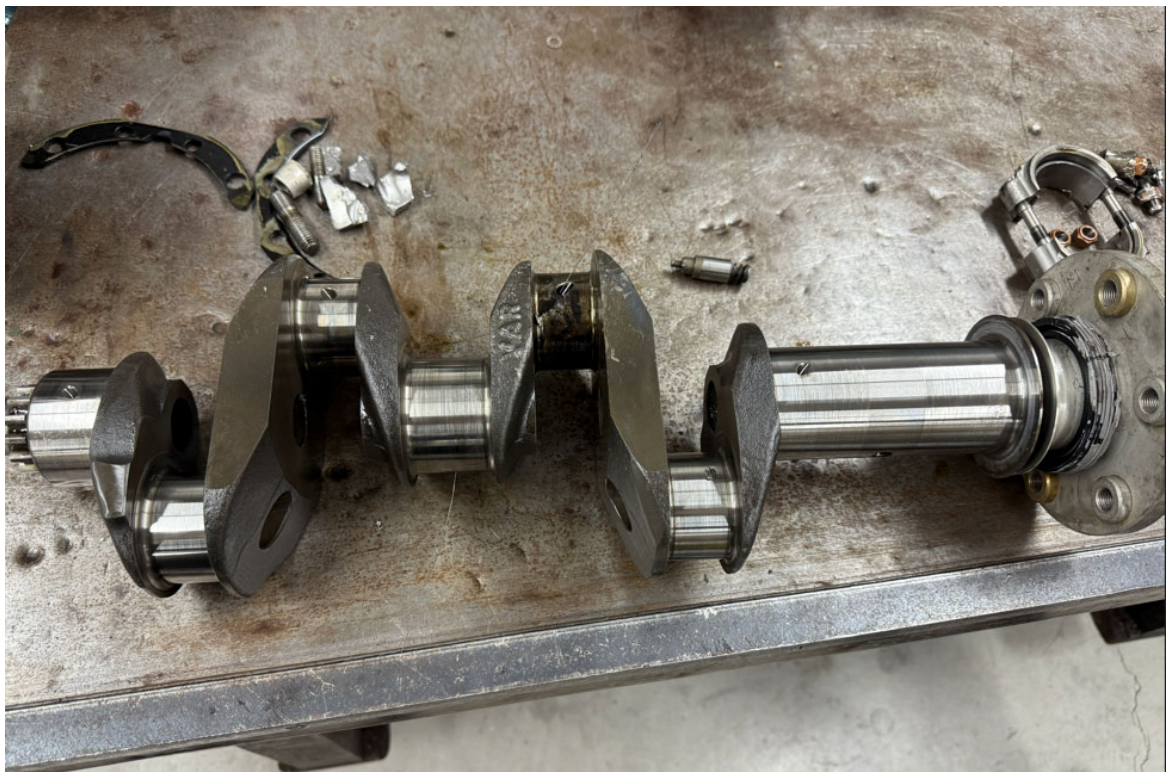
- The crankshaft and camshaft were removed from the crankcase
- The crankshaft's #2 connecting rod journal was darkened and black consistent with a high heat and insufficient lubrication event, the journal also had gouges, scoring and scratches on it
- The #2 connecting rod bearing was destroyed
- All four main crankshaft journals, the #1, #3, and #4 connecting rod journals, and their respective main and connecting rod bearings had scoring consistent with metal contamination
- The crankshaft gear was secure, and the alignment dowel pin was not sheared

**Figure 13: Crankshaft**

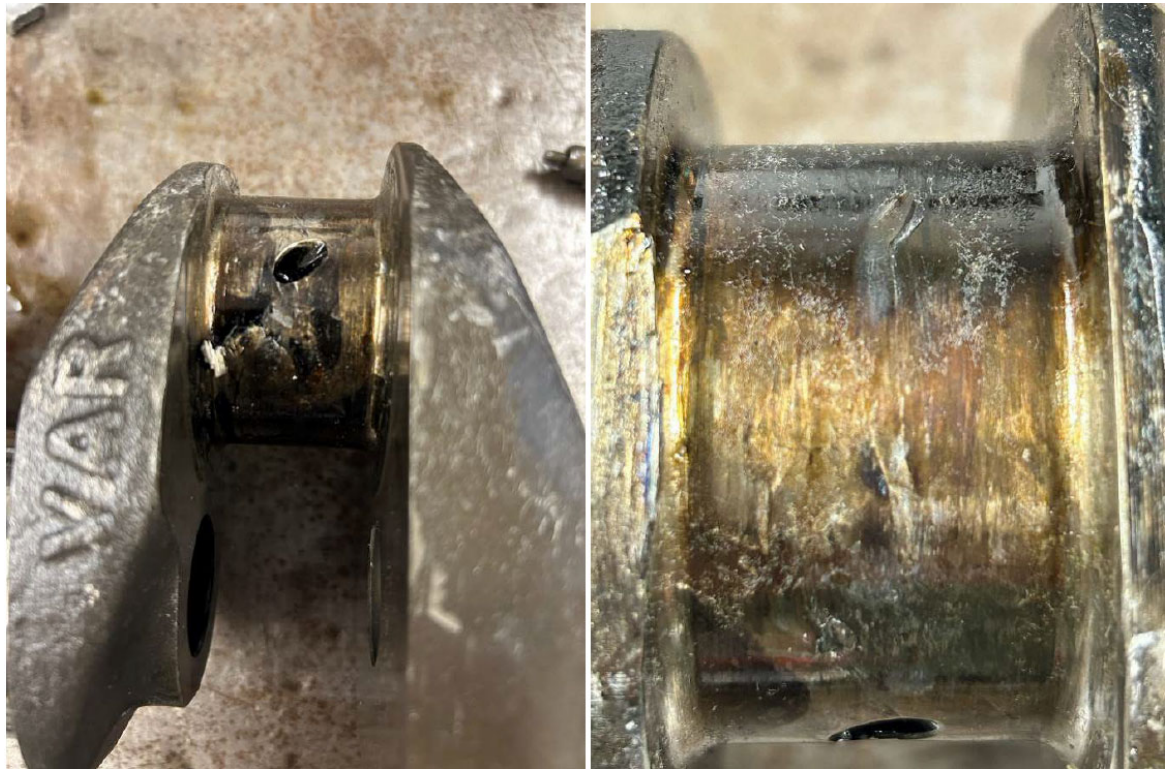
**Figure 14: Crankshaft's #2 connecting rod journal had indication of heat damage**

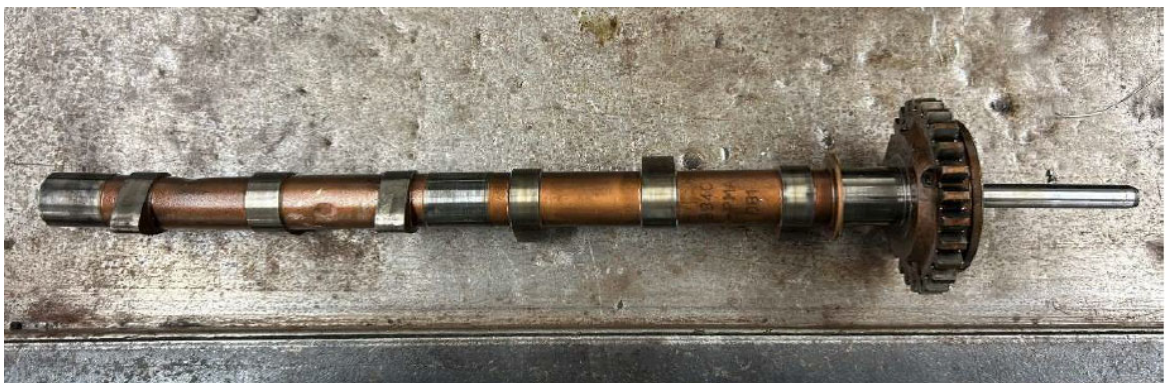
- The camshaft remained in one piece but was bent, there were several strike marks and gouges along the length of the shaft, no pitted, worn, or spalled lobes were observed
- The camshaft gear was in one piece, and the tach drive adapter remained installed

**Figure 15: Camshaft**

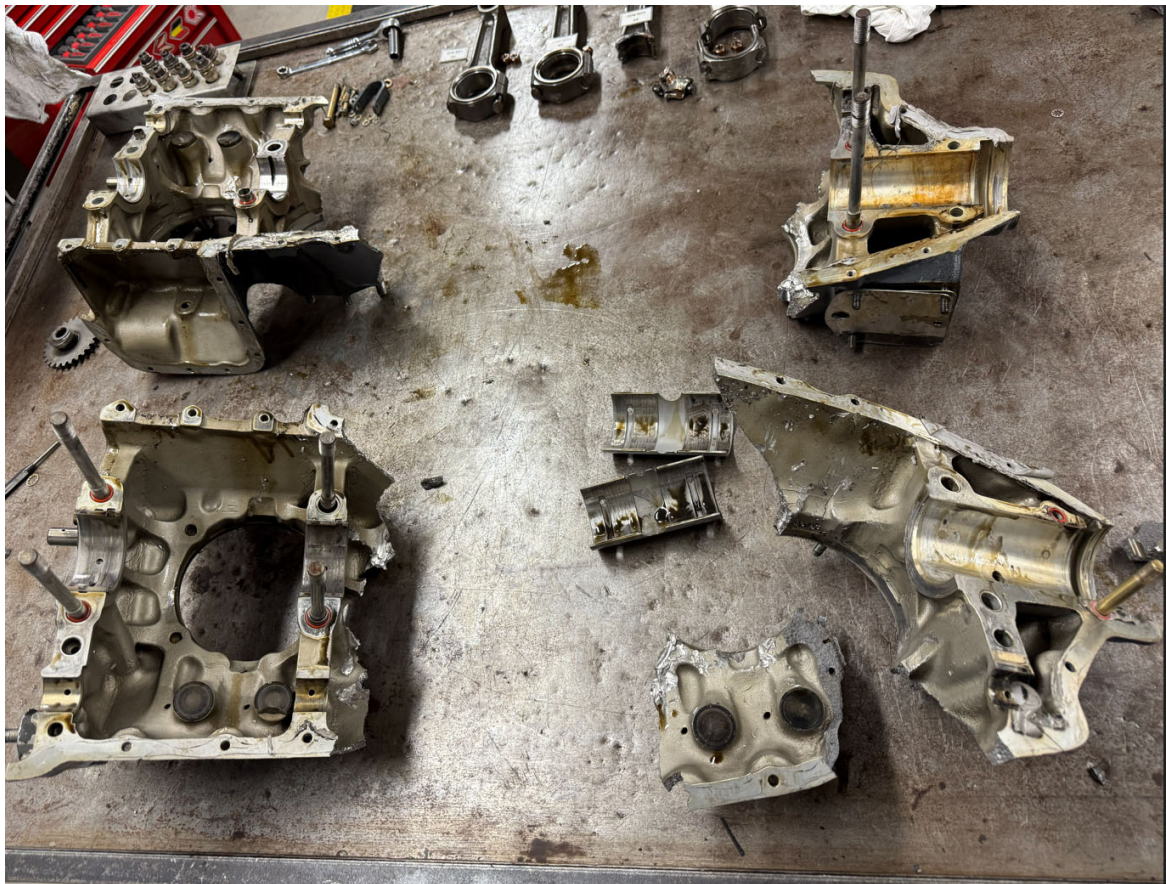
- The crankcase was fragmented
- The oil passages in the crankcase were inspected, using a wire to see if they were clear
- The #3 main journal oil passage was found filled in with material, underneath the bearing
- There was additional material build-up around the #3 main oil passage as well as two distinct grinding wheel marks adjacent to the weld location

**Figure 16: Crankcase was fragmented**

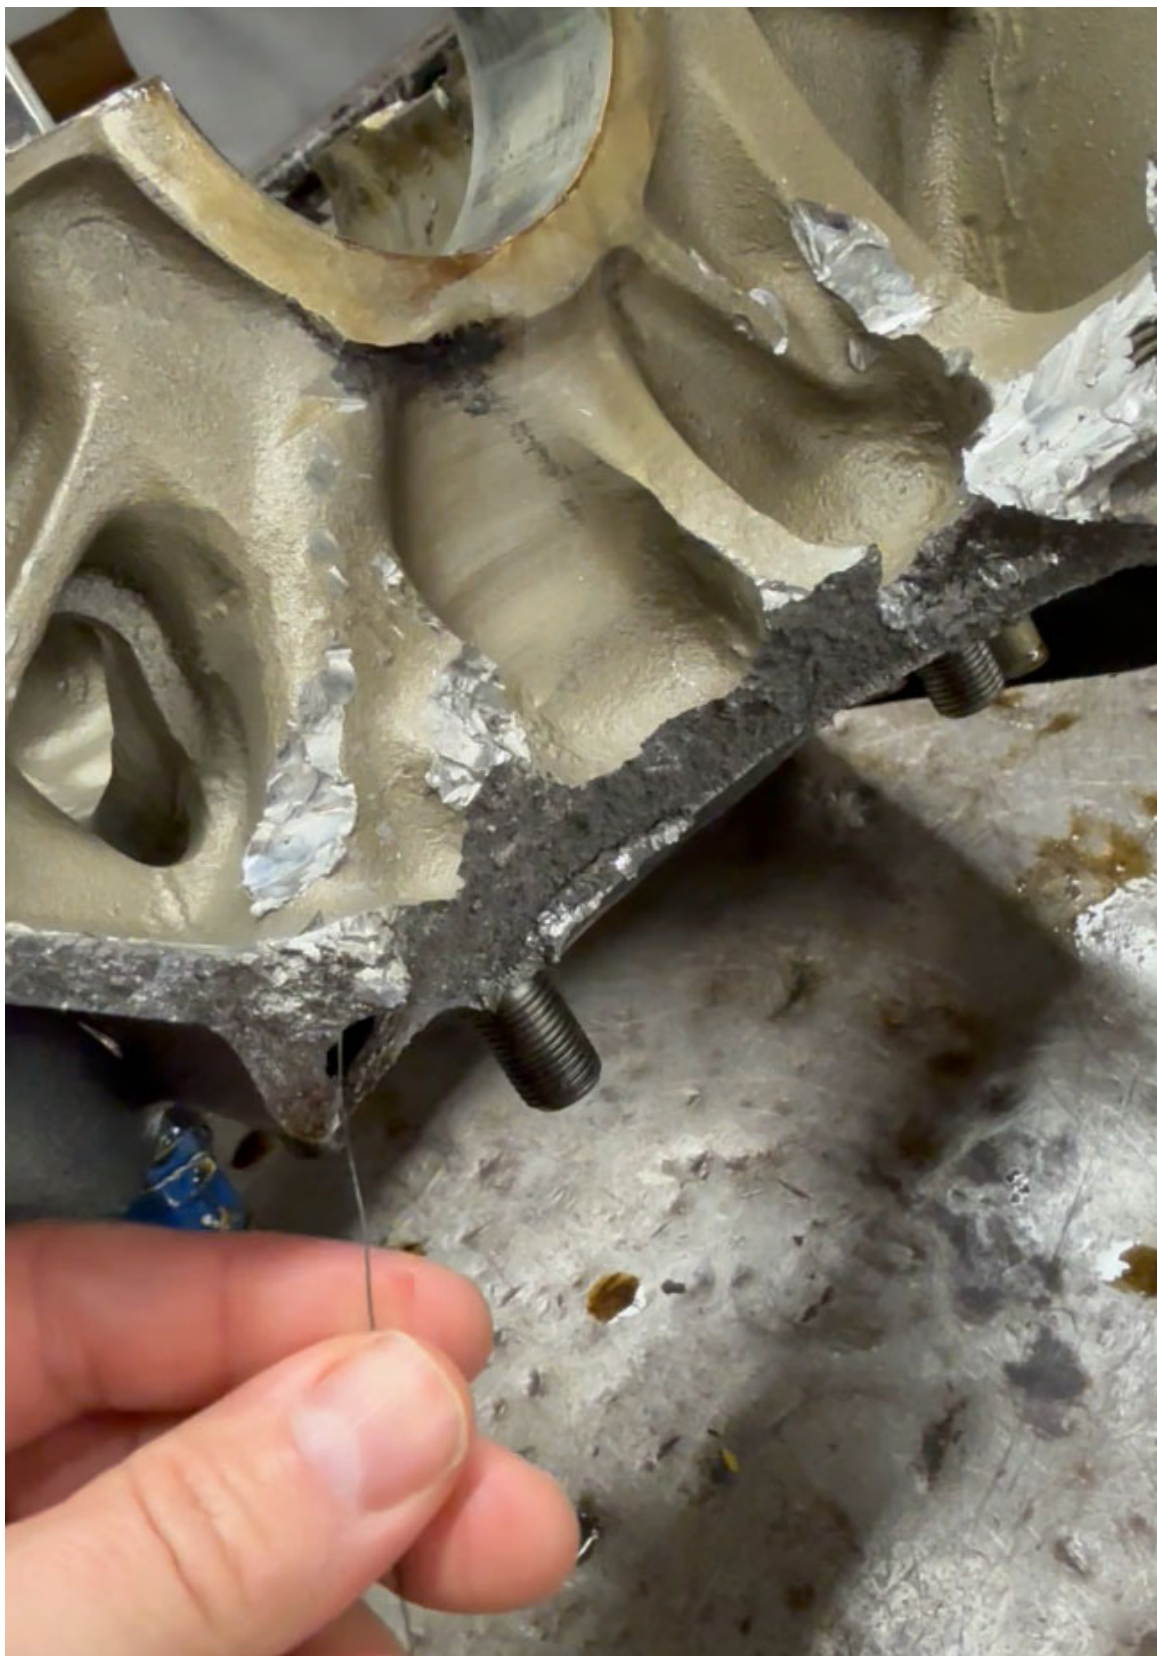
Figure 17: Oil passage found blocked

SIA-Iceland concluded that the weld repair done in that area, blocking the oil passage hole, was the cause for the engine failure, as it prevented oil from traveling to the main bearing, through the crankshaft oil passage and to the connecting rod bearing.

SIA- Iceland recommends to Divco to review this investigation report and to incorporate the necessary safety related changes to prevent oil passage blocking from re-occurring during welding operation.

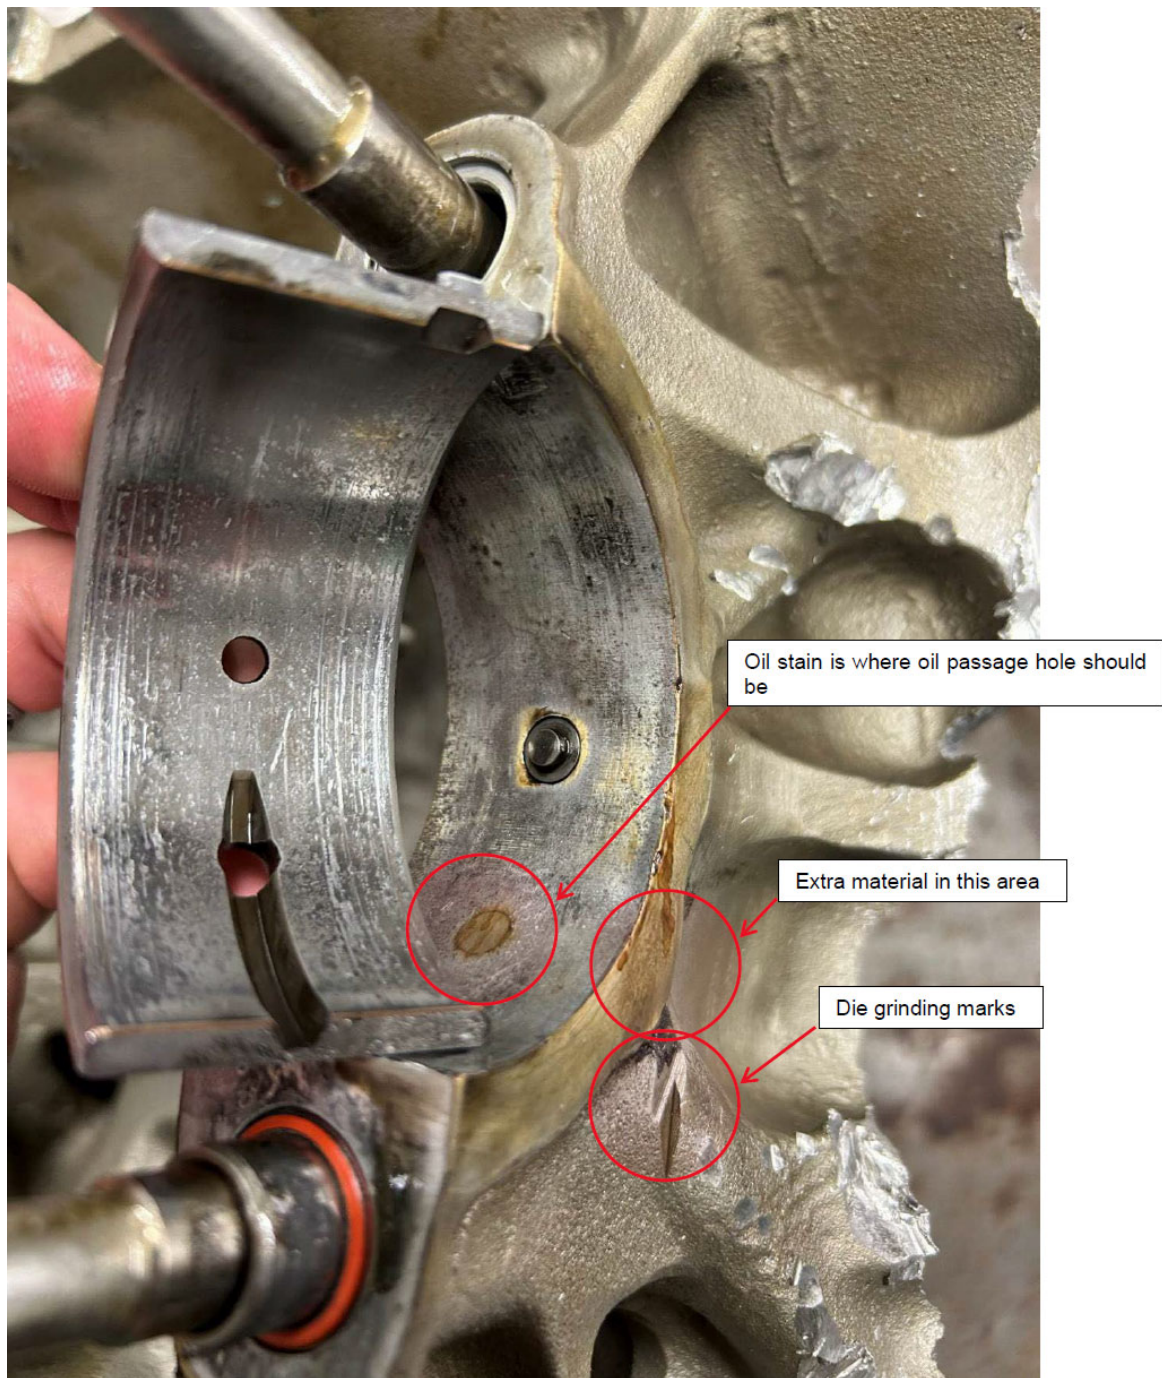
**Figure 18: Oil passage blocked under #3 main (center) crankshaft bearing**

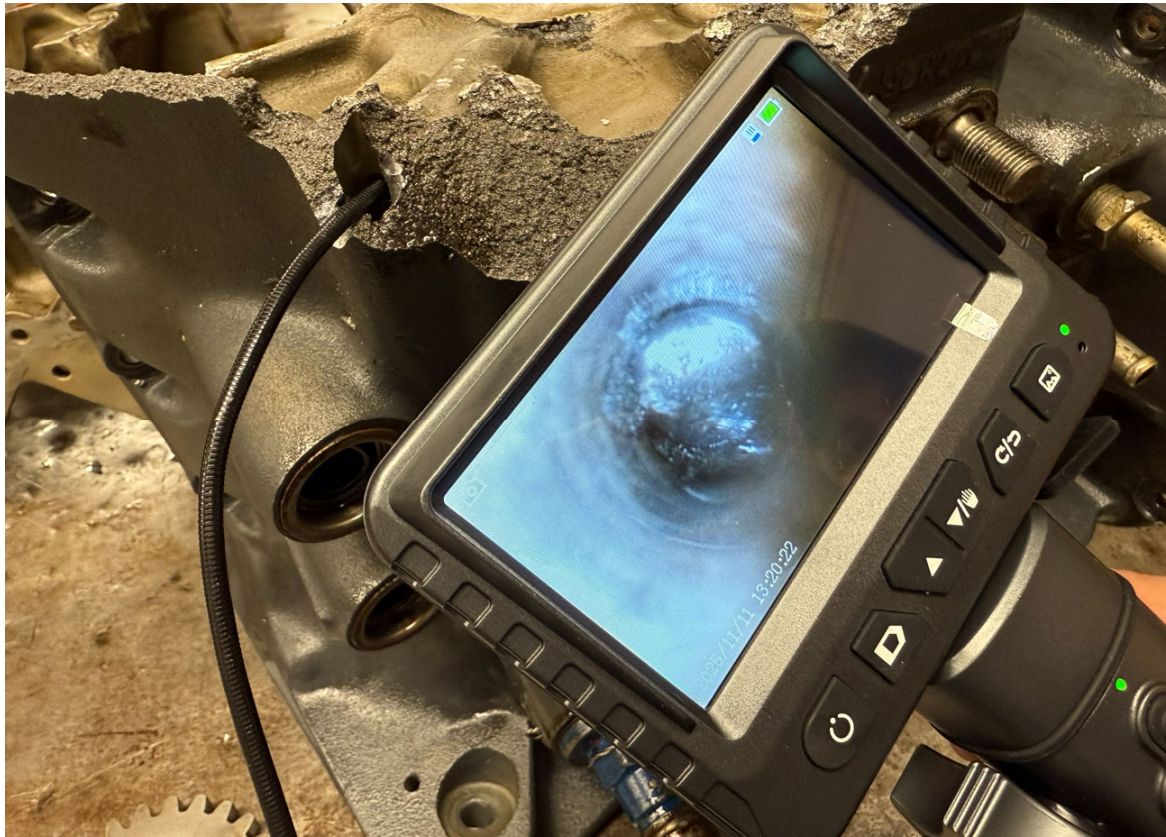
A borescope was used to examine the other side of the #3 main bearing oil passage, which was opened due to the crankcase being fragmented. This revealed puddled aluminum on the backside of the #3 bearing saddle, consistent with left over material from a weld repair.

**Figure 19: Blockage verified by a borescope**

SIA- Iceland recommends to the FAA and EASA to issue an Advisory Circular (AC), or similar lessons learned guidance, highlighting the importance that welding repair operation do not do adverse damage to engine oil passages or other parts of its lubrication system.
